Solenoid Electrical Feedthrough

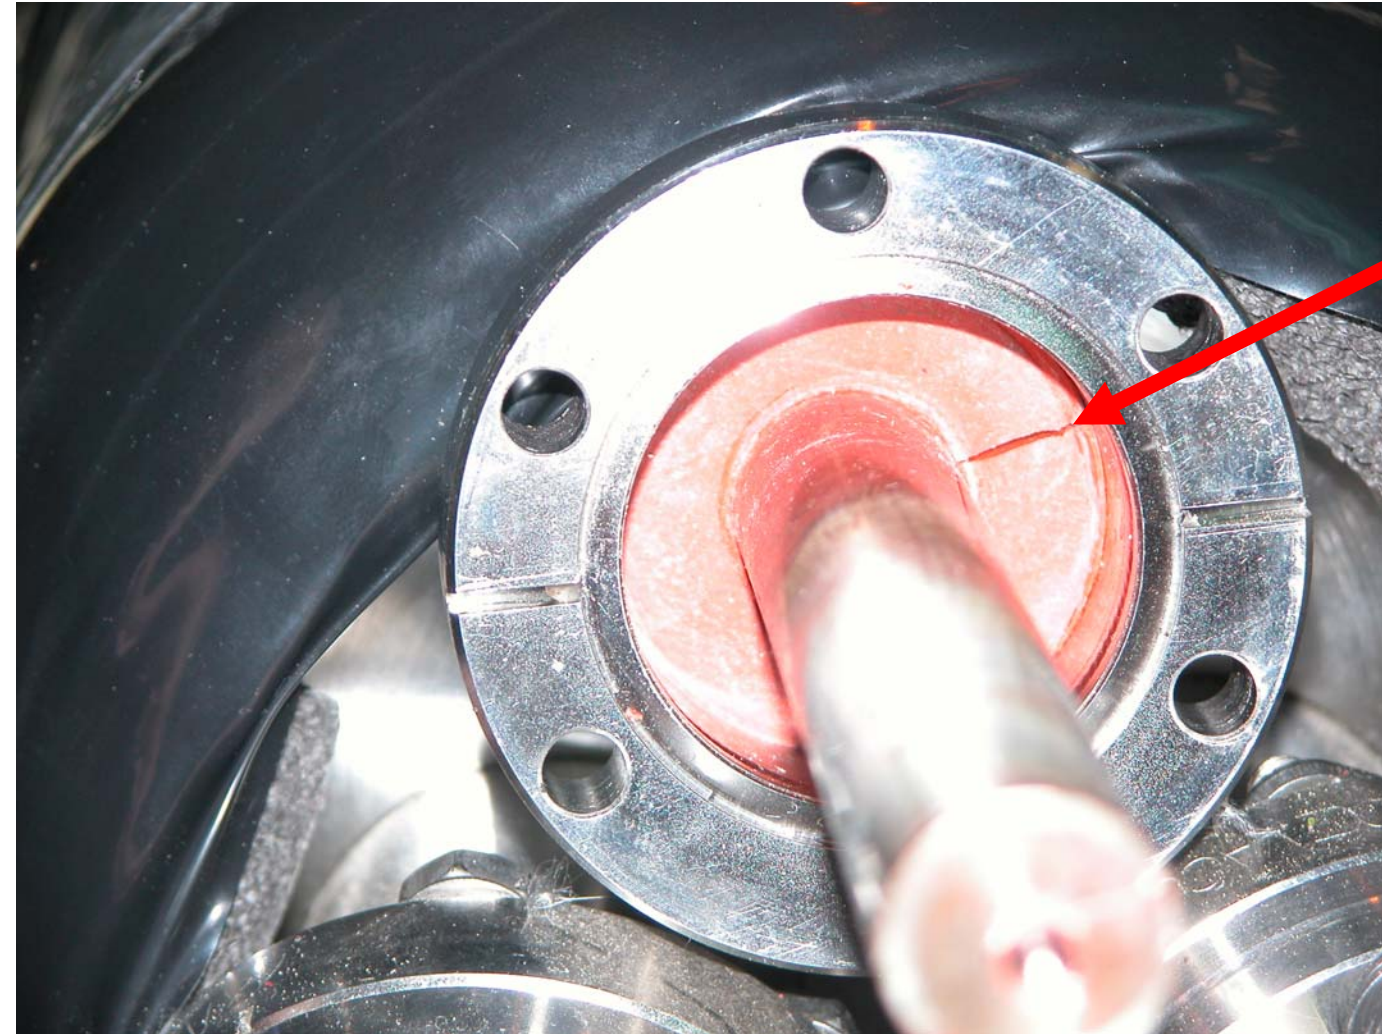
Source of the problem located

Radial cracks
observed in
several
silicone
packing
disks

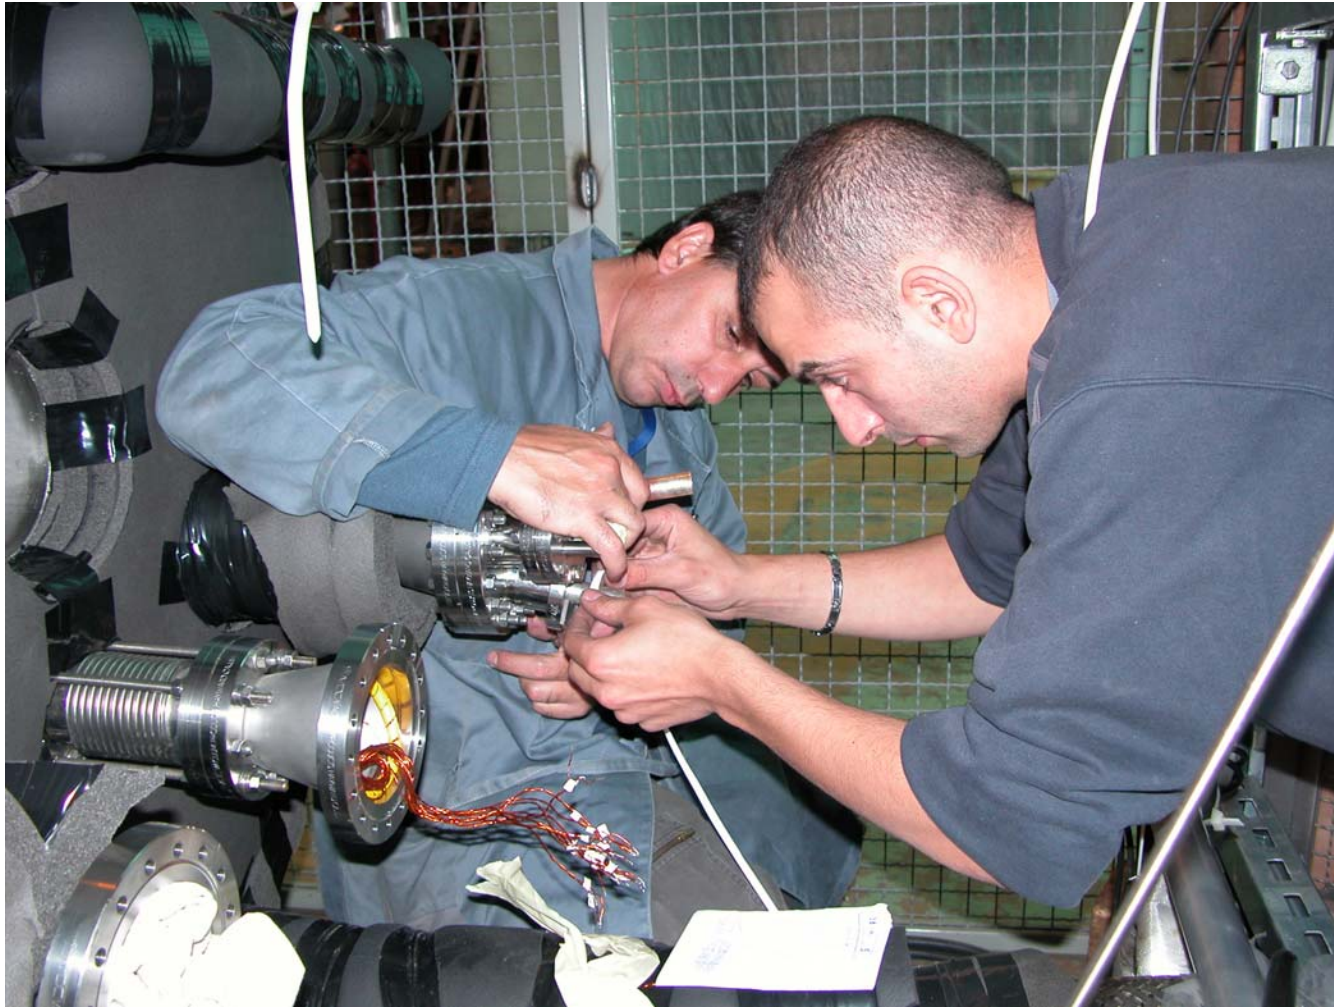
May 29, 2007

The Reassembly Work

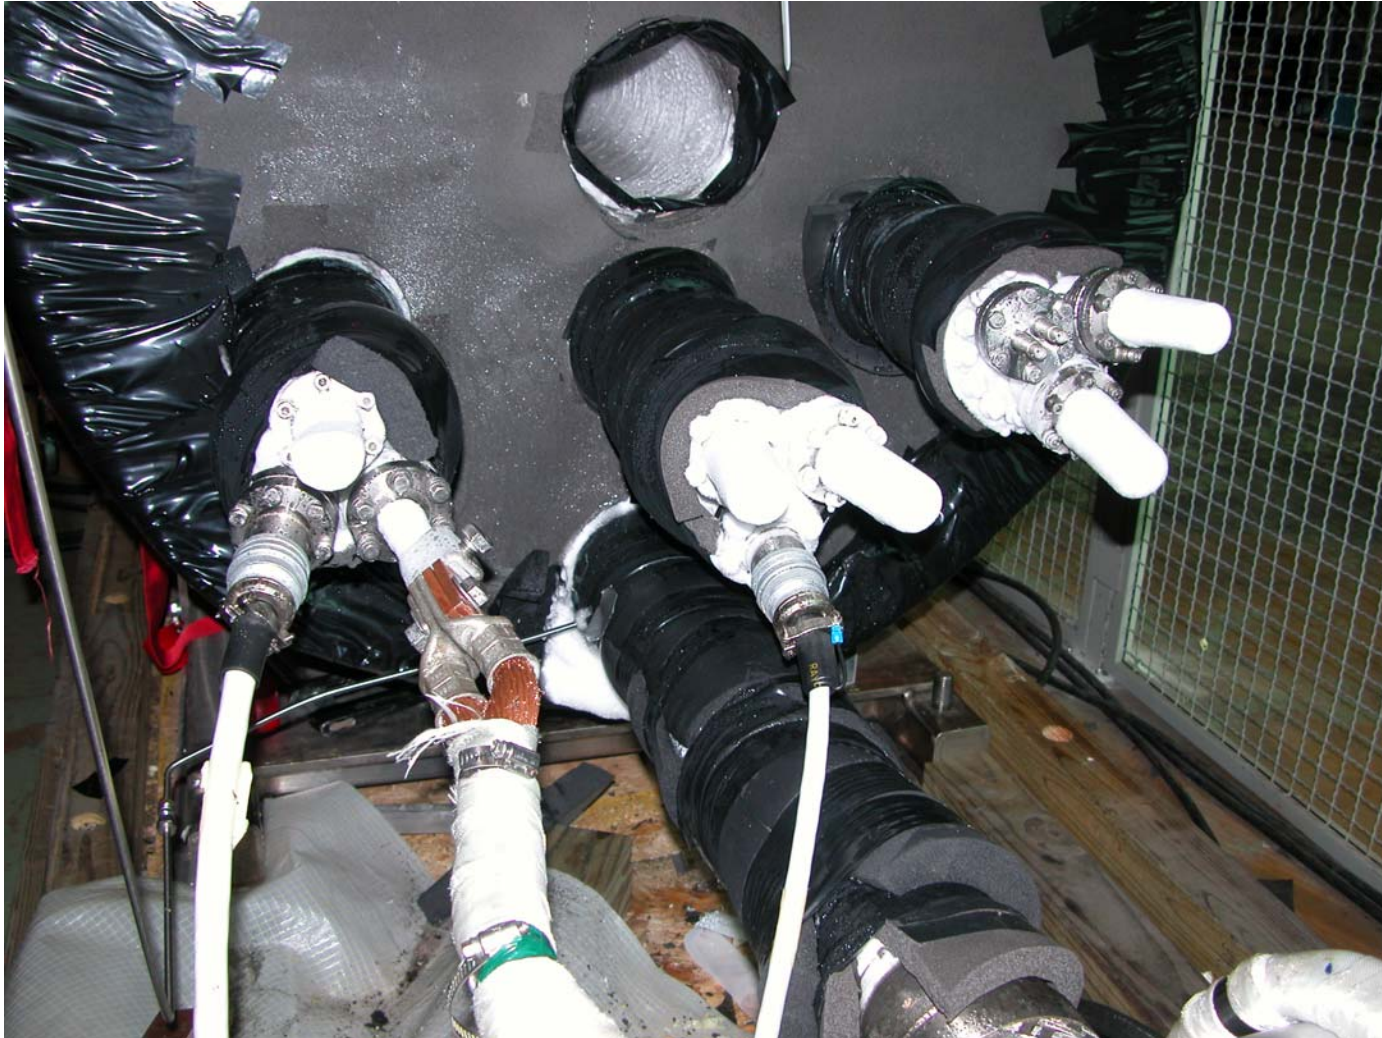
June 5, 2007

Frost Buildup

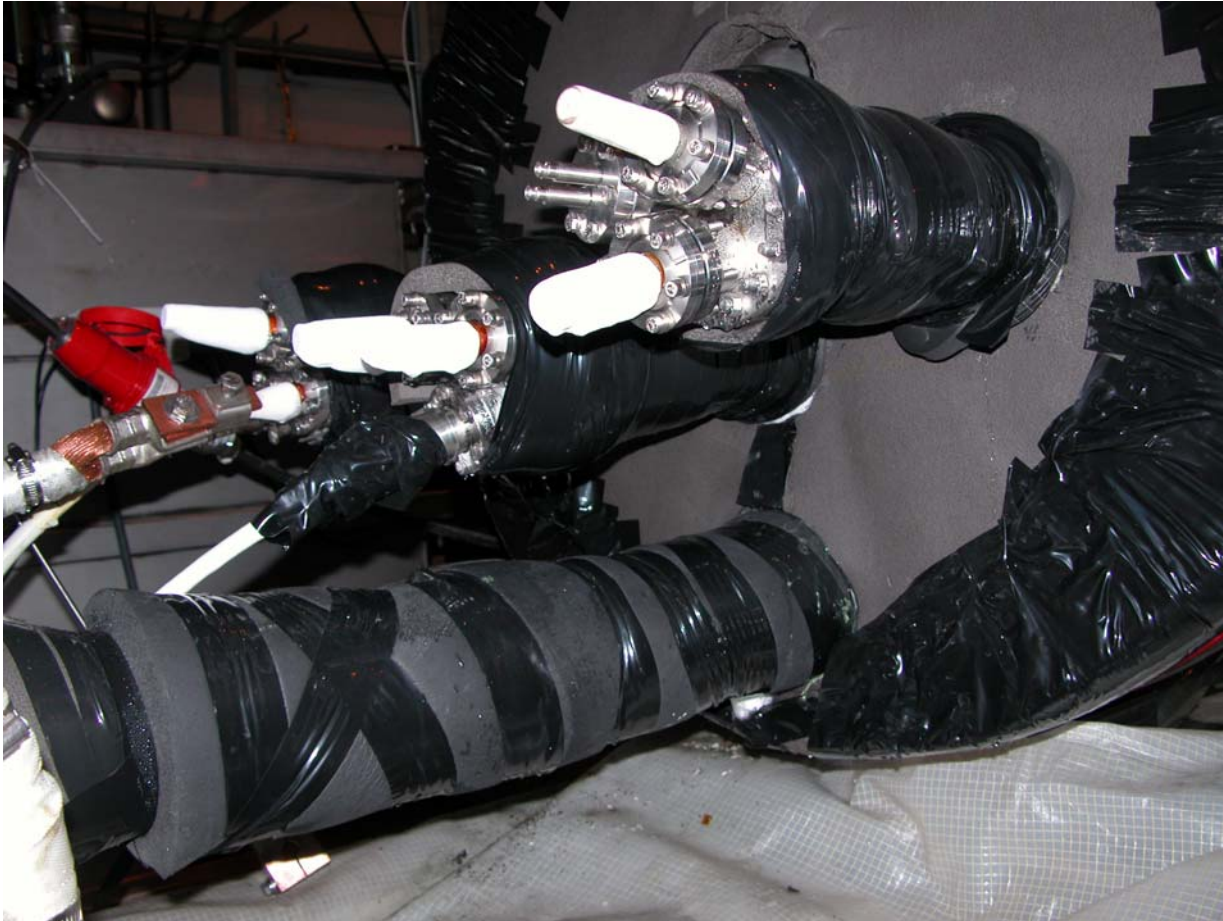
June 6, 2007

Frost Buildup Reduced

Magnet
temperatures
from 83° to
 130° K
